Temporal Plots of Field and Laboratory Data for Each Site Sampled in 2011 and 2012

Report 4.2.3

Ecological Engineering Research Program
School of Engineering & Computer Sciences
University of the Pacific
3601 Pacific Avenue
Chambers Technology Center
Stockton, CA 95211

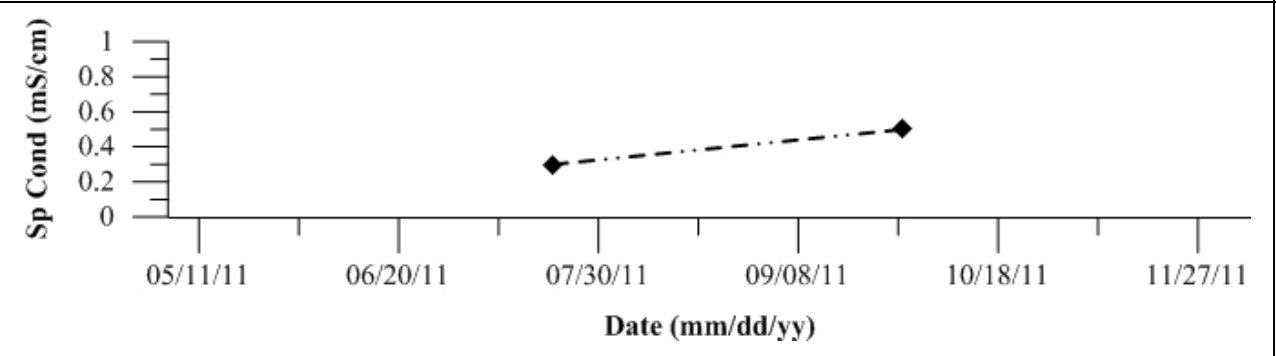
Figure 37: Grab sample specific conductance as measured with a YSI 6600V2 data sonde for Site 10 SJR at Lander Avenue. Data collected in 2011.

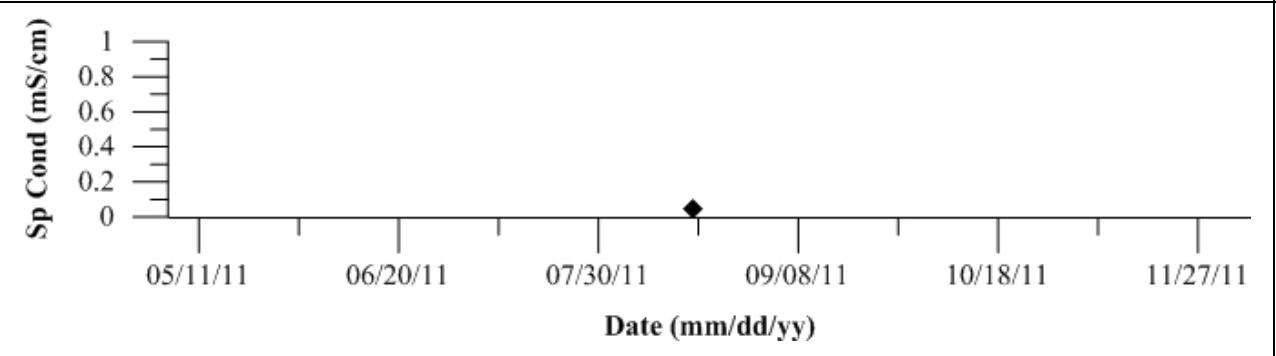
Figure 40: Grab sample specific conductance as measured with a YSI 6600V2 data sonde for Site 14 Tuolumne River at Shiloh. Data collected in 2011.

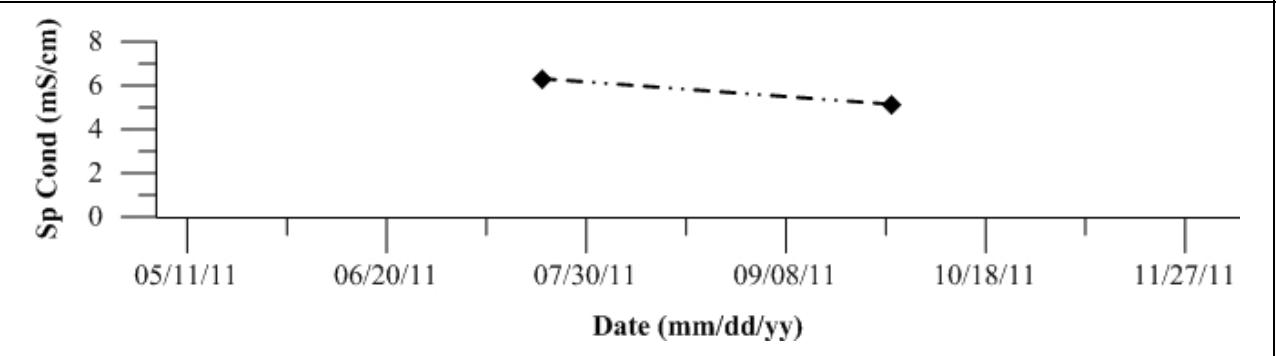
Figure 49: Grab sample specific conductance as measured with a YSI 6600V2 data sonde for Site 44 San Luis Drain End. Data collected in 2011.

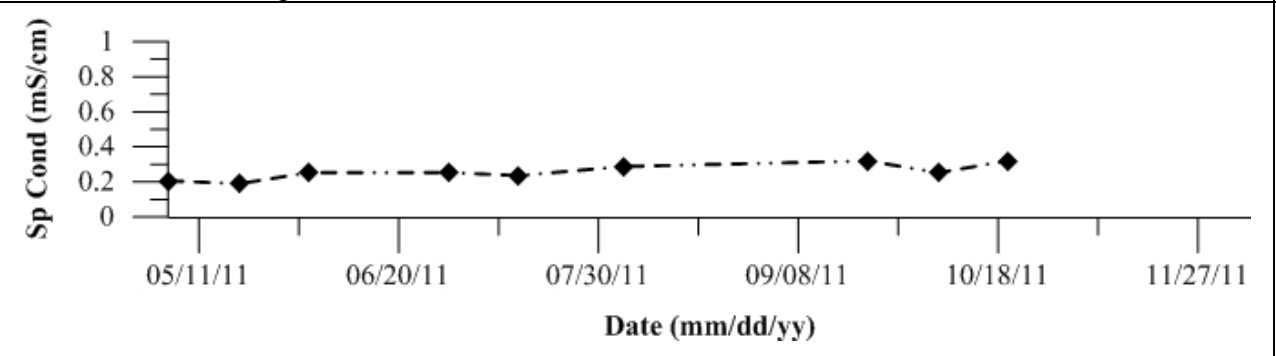
Figure 58: Grab sample specific conductance as measured with a YSI 6600V2 data sonde for Site 421 5 Mile Slough at Hazelwood Ave. Data collected in 2011.

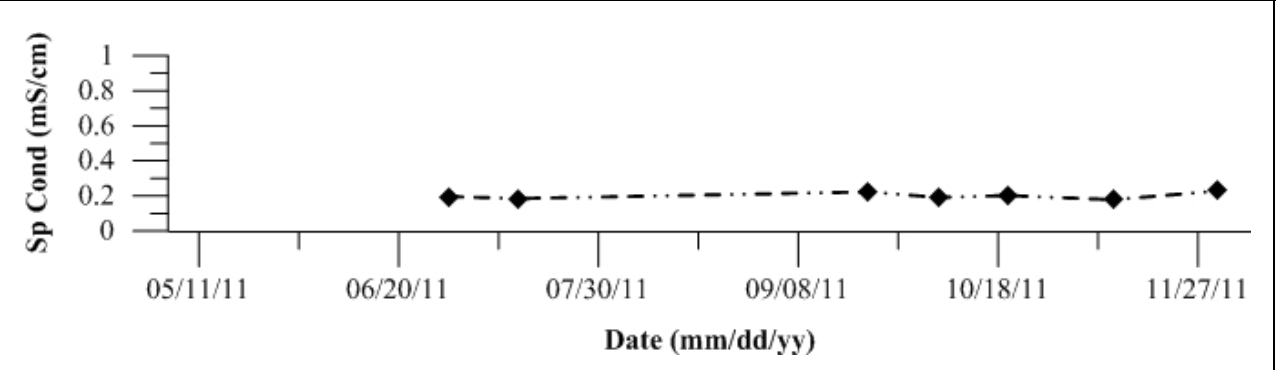
Figure 64: Grab sample specific conductance as measured with a YSI 6600V2 data sonde for Site 433 Paradise Marina (Node 70). Data collected in 2011.

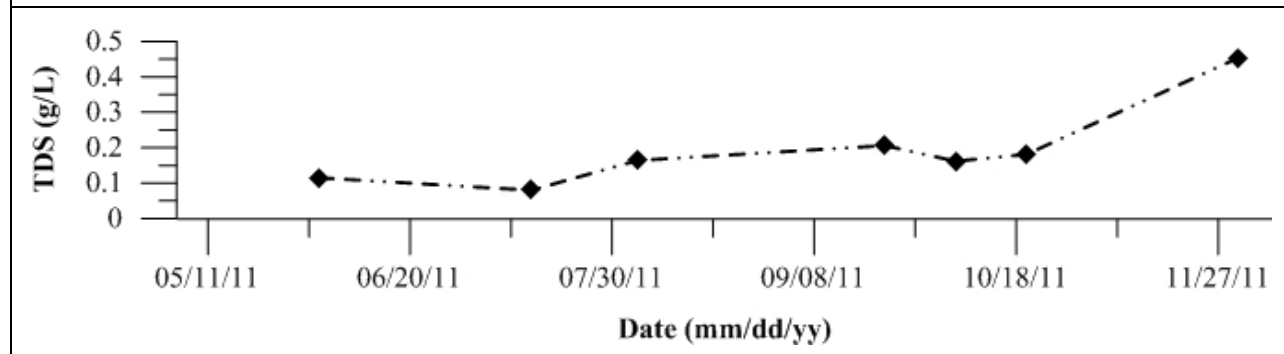
Figure 66: Grab sample Total Dissolved Solids (TDS) as measured with a YSI 6600V2 data sonde for Site 4 SJR at Mossdale. Data collected in 2011.

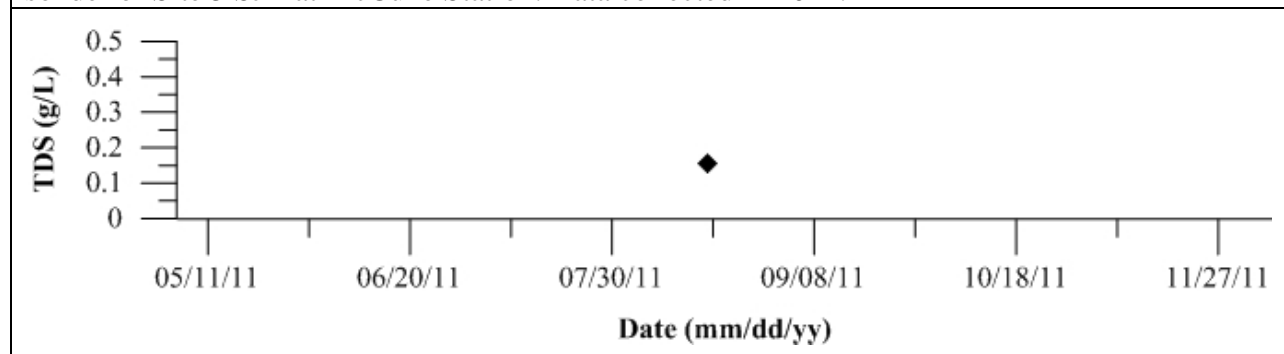
Figure 67: Grab sample Total Dissolved Solids (TDS) as measured with a YSI 6600V2 data sonde for Site 5 SJR at McCune Station. Data collected in 2011.

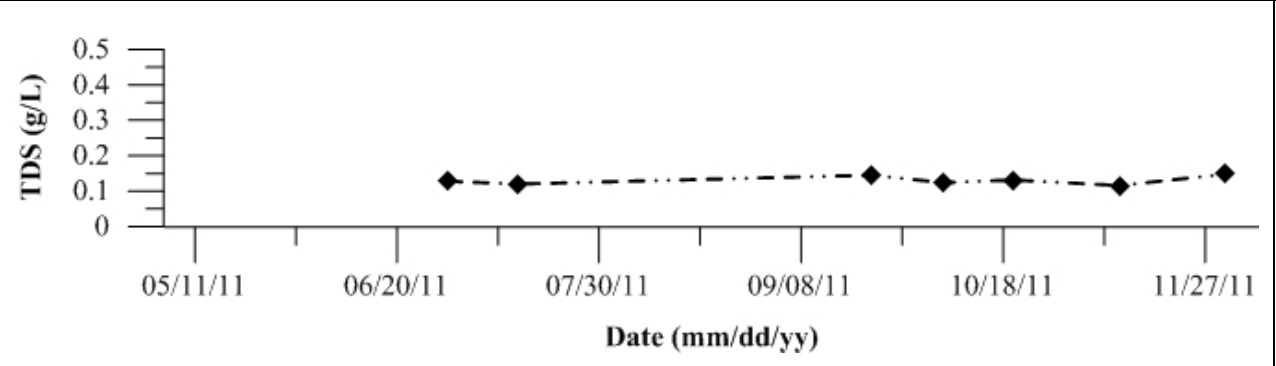
Figure 96: Grab sample Total Dissolved Solids (TDS) as measured with a YSI 6600V2 data sonde for Site 433 Paradise Marina (Node 70). Data collected in 2011.

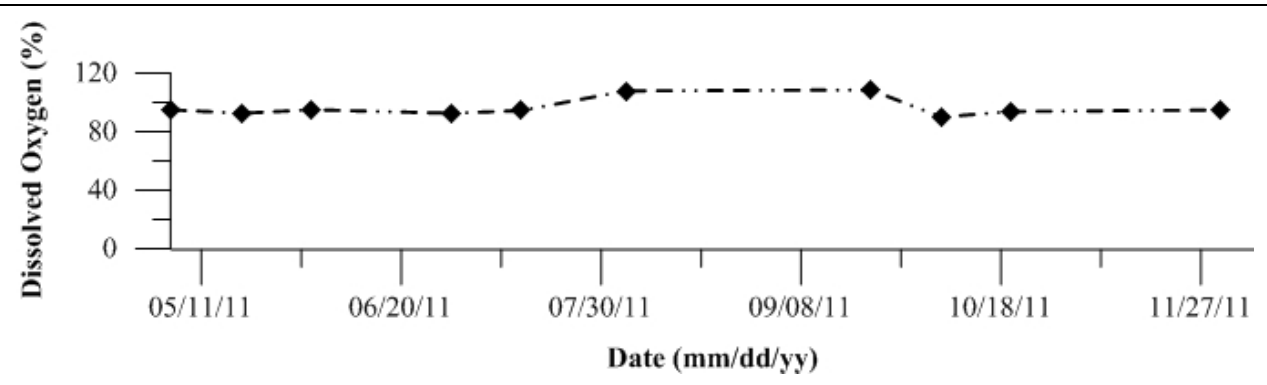
Figure 97: Grab sample Dissolved Oxygen (DO) percentage as measured with a YSI 6600V2 data sonde for Site 2 SJR at Dos Reis Park. Data collected in 2011.

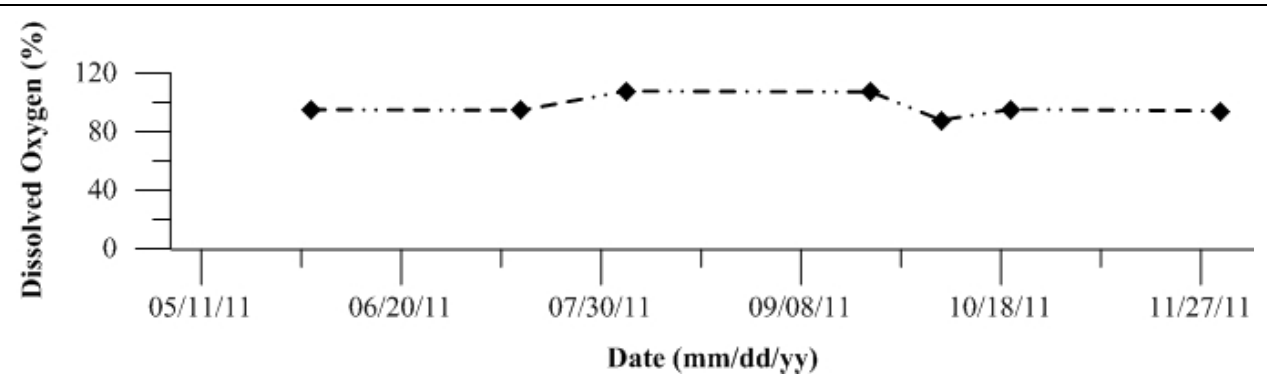
Figure 98: Grab sample Dissolved Oxygen (DO) percentage as measured with a YSI 6600V2 data sonde for Site 4 SJR at Mossdale. Data collected in 2011.

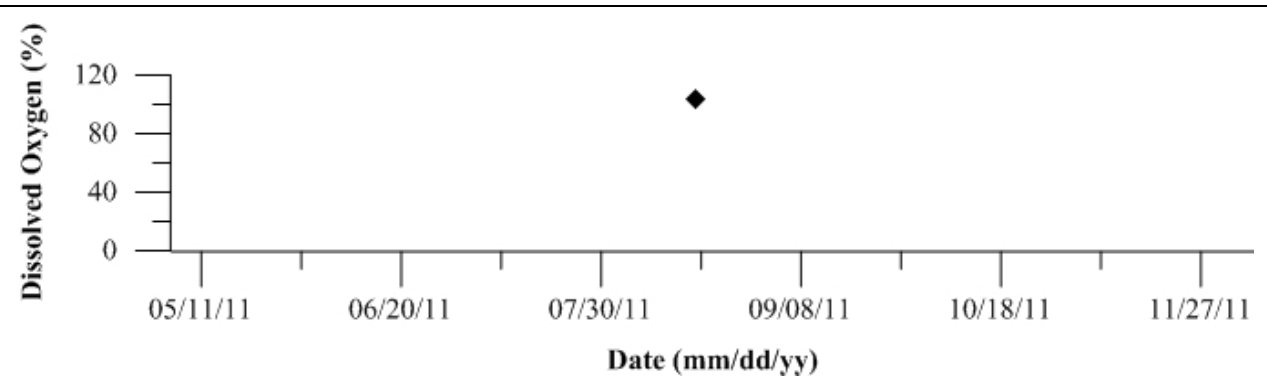
Figure 99: Grab sample Dissolved Oxygen (DO) percentage as measured with a YSI 6600V2 data sonde for Site 5 SJR at McCune Station. Data collected in 2011.

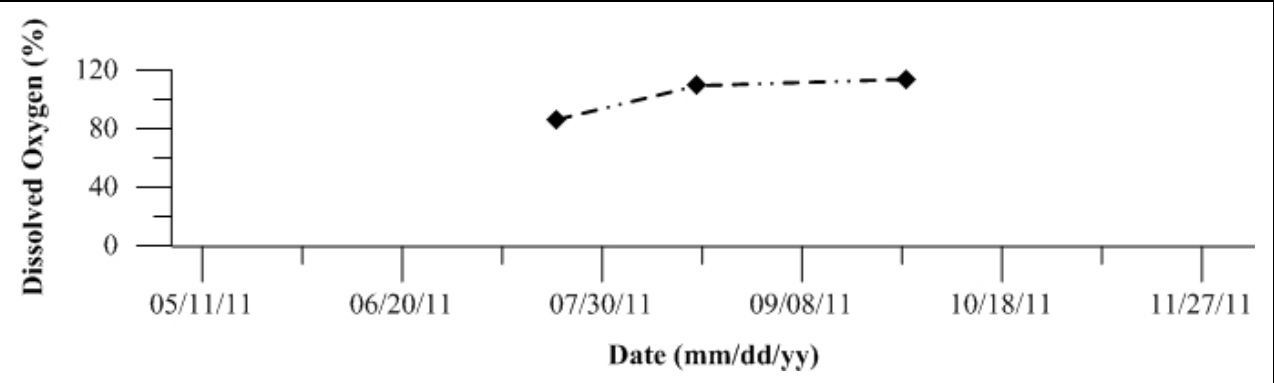
Figure 100: Grab sample Dissolved Oxygen (DO) percentage as measured with a YSI 6600V2 data sonde for Site 7 SJR at Patterson. Data collected in 2011.

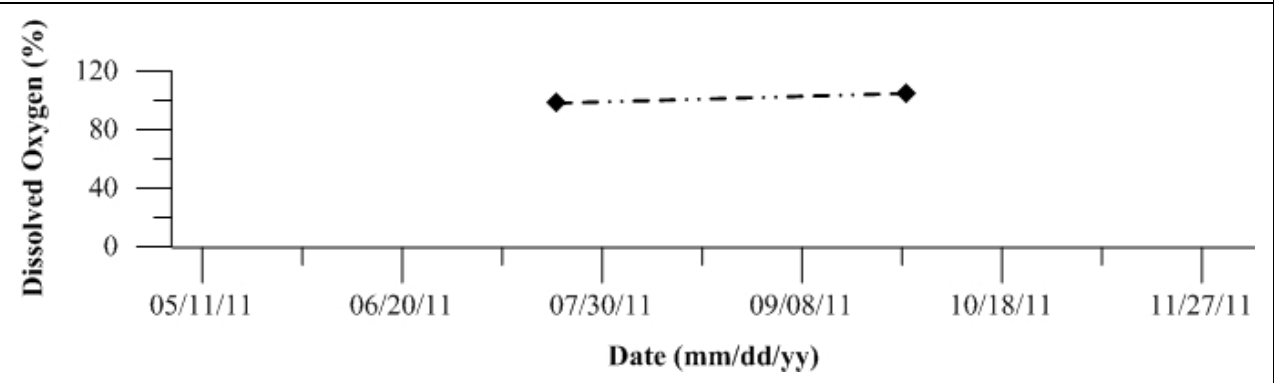
Figure 101: Grab sample Dissolved Oxygen (DO) percentage as measured with a YSI 6600V2 data sonde for Site 10 SJR at Lander Avenue. Data collected in 2011.

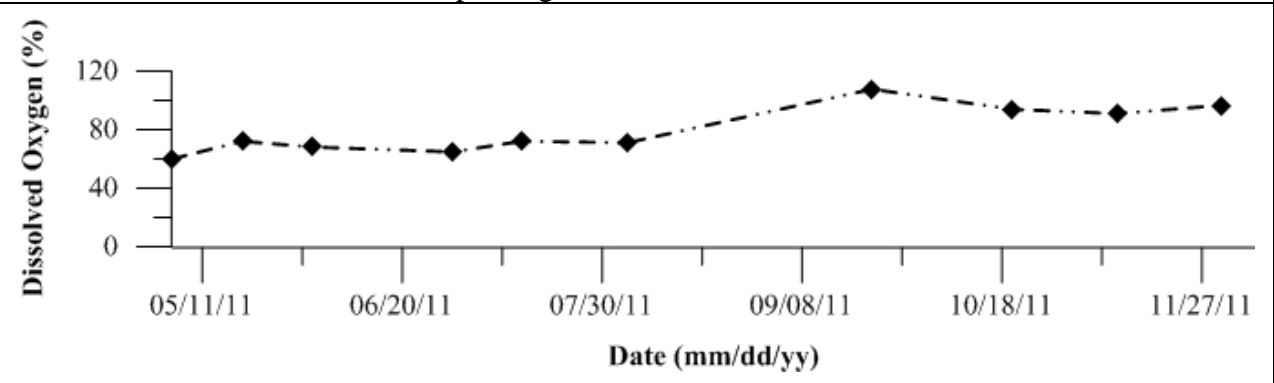
Figure 102: Grab sample Dissolved Oxygen (DO) percentage as measured with a YSI 6600V2 data sonde for Site 11 French Camp Slough. Data collected in 2011.

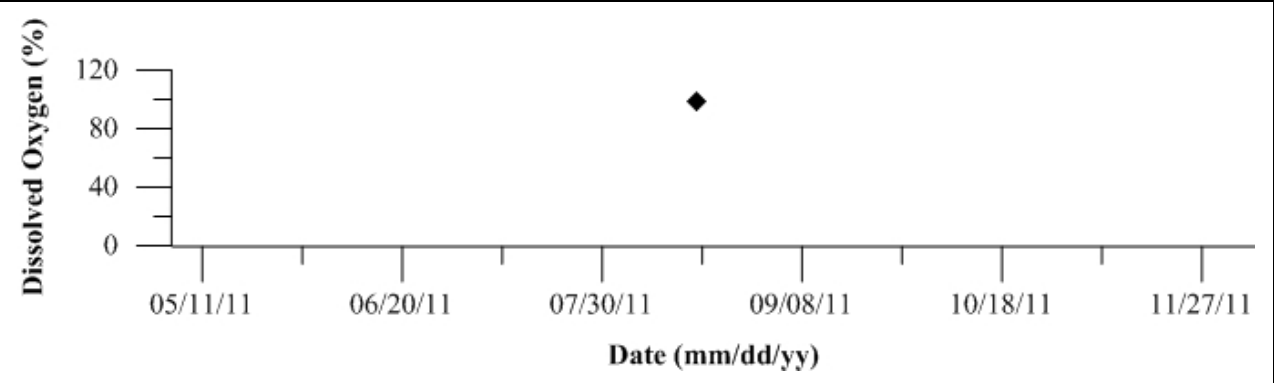
Figure 103: Grab sample Dissolved Oxygen (DO) percentage as measured with a YSI 6600V2 data sonde for Site 12 Stanislaus River at Caswell Park. Data collected in 2011.

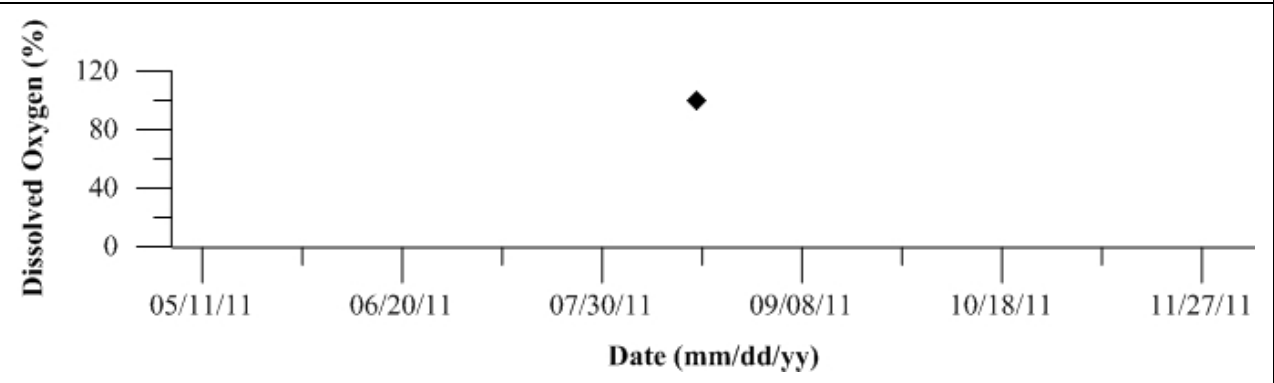
Figure 104: Grab sample Dissolved Oxygen (DO) percentage as measured with a YSI 6600V2 data sonde for Site 14 Tuolumne River at Shiloh. Data collected in 2011.

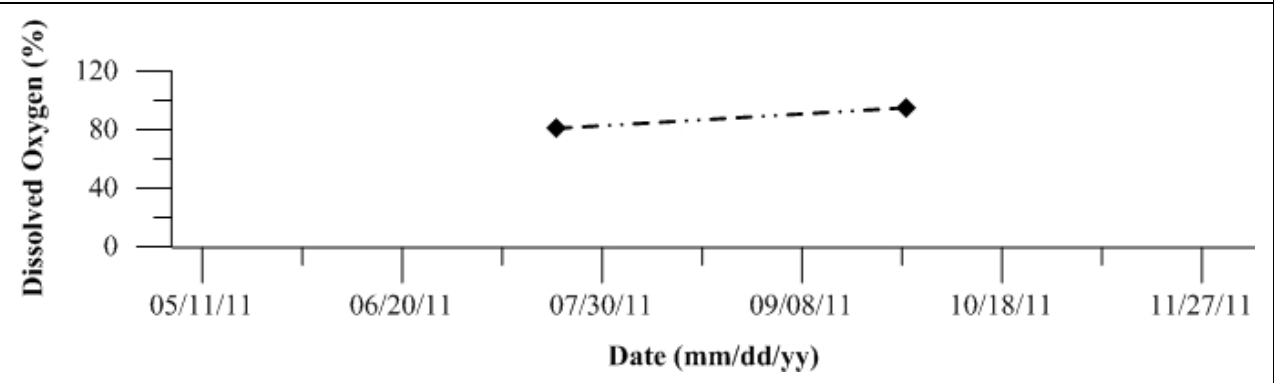
Figure 105: Grab sample Dissolved Oxygen (DO) percentage as measured with a YSI 6600V2 data sonde for Site 16 Merced River at River Road. Data collected in 2011.

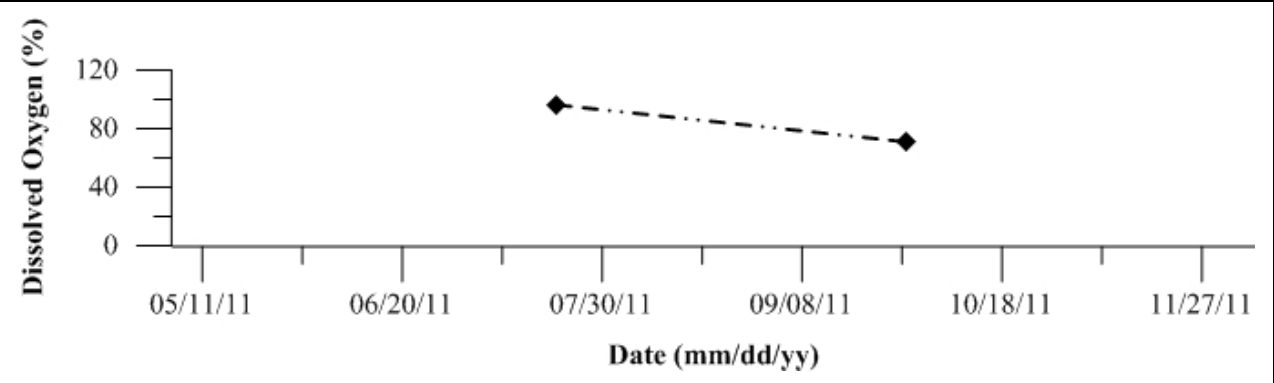
Figure 106: Grab sample Dissolved Oxygen (DO) percentage as measured with a YSI 6600V2 data sonde for Site 18 Mud Slough near Gustine. Data collected in 2011.

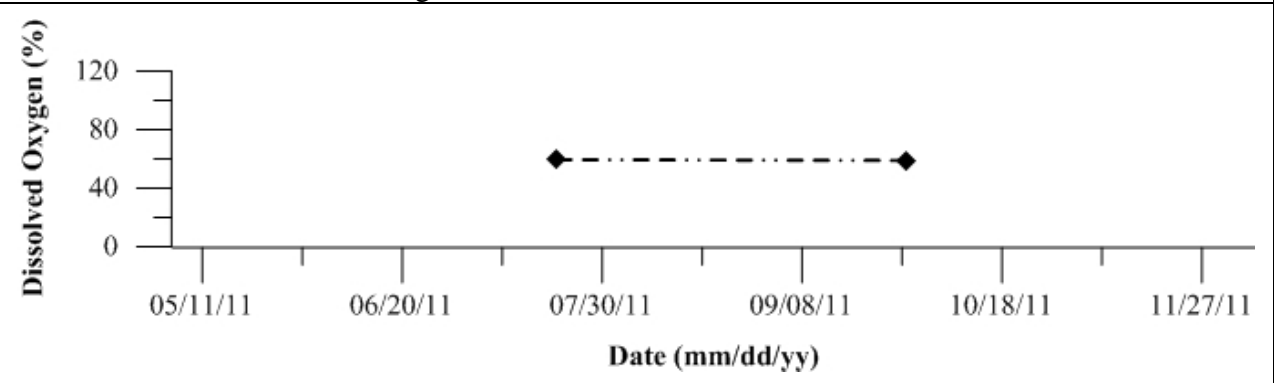
Figure 107: Grab sample Dissolved Oxygen (DO) percentage as measured with a YSI 6600V2 data sonde for Site 19 Salt Slough at Lander Avenue. Data collected in 2011.

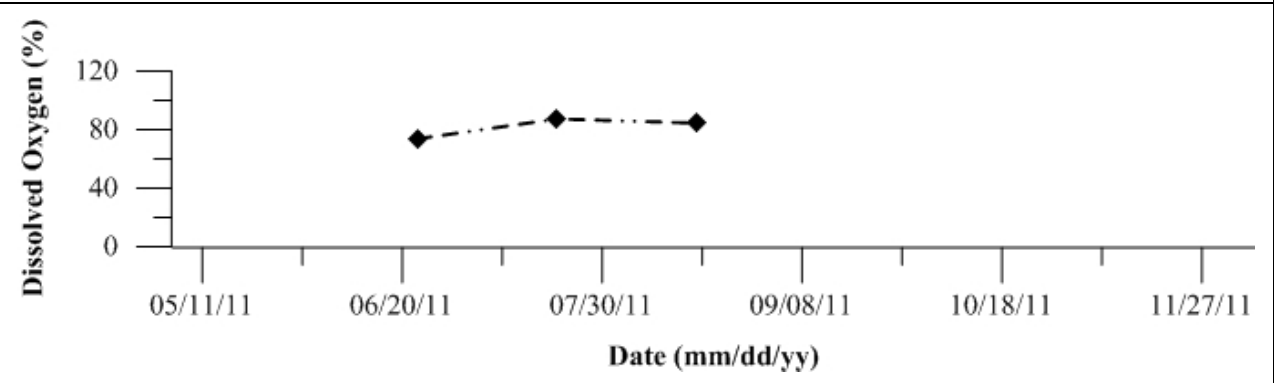
Figure 108: Grab sample Dissolved Oxygen (DO) percentage as measured with a YSI 6600V2 data sonde for Site 21 Orestimba Creek at River Road. Data collected in 2011.

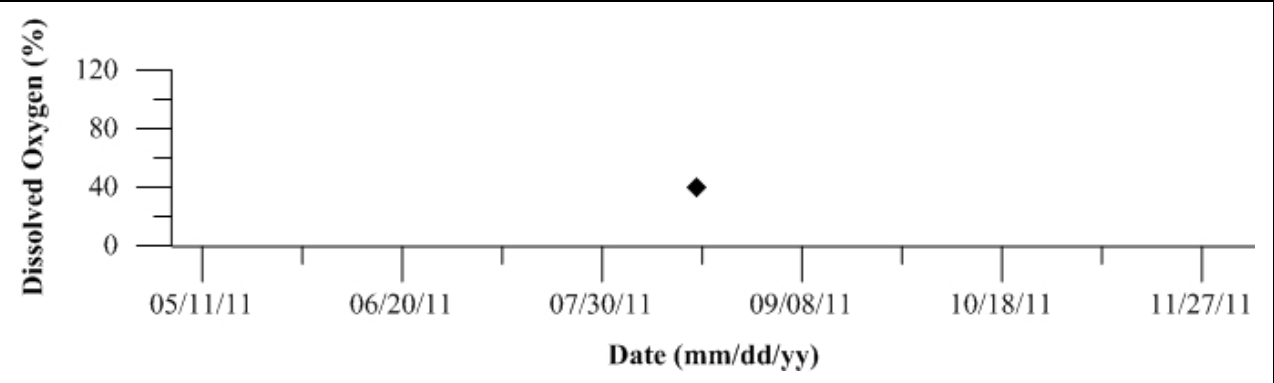
Figure 109: Grab sample Dissolved Oxygen (DO) percentage as measured with a YSI 6600V2 data sonde for Site 25 Miller Lake at Stanislaus River

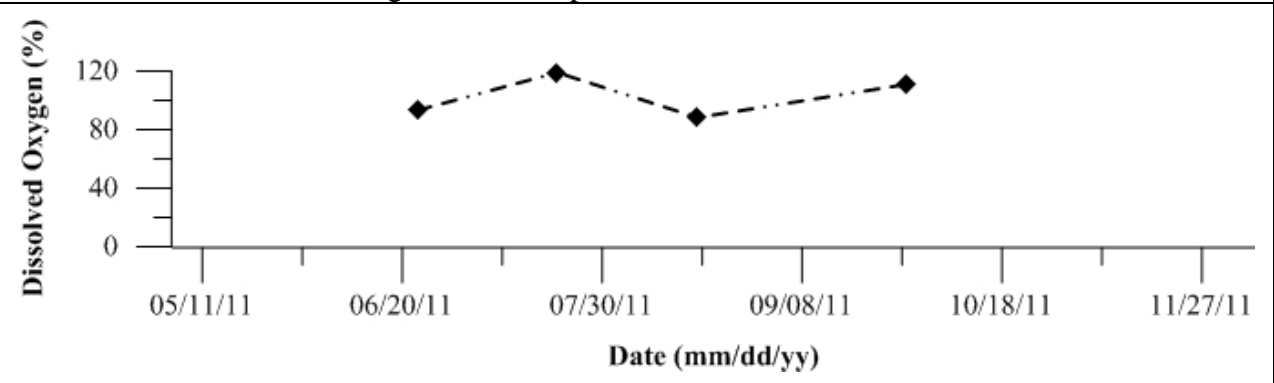
Figure 110: Grab sample Dissolved Oxygen (DO) percentage as measured with a YSI 6600V2 data sonde for Site 29 Harding Drain at Carpenter Road. Data collected in 2011.

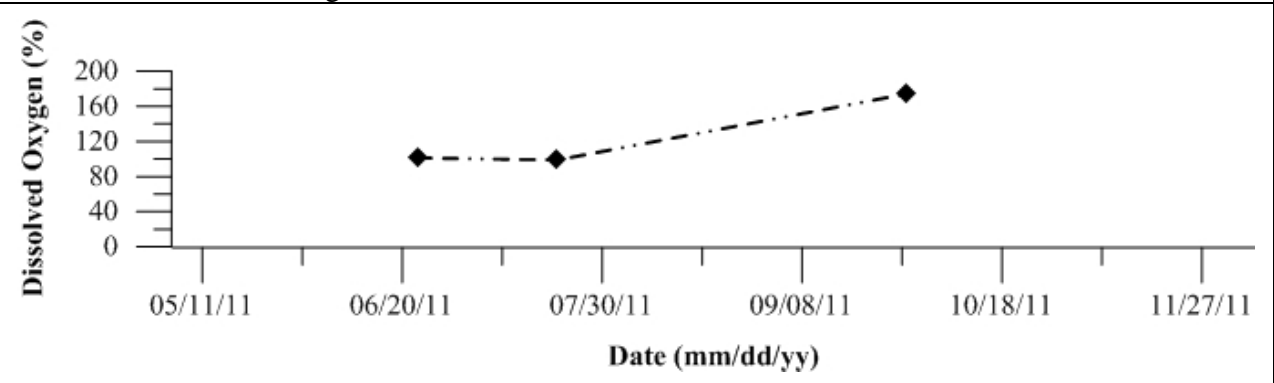
Figure 111: Grab sample Dissolved Oxygen (DO) percentage as measured with a YSI 6600V2 data sonde for Site 34 Ingram Creek. Data collected in 2011.

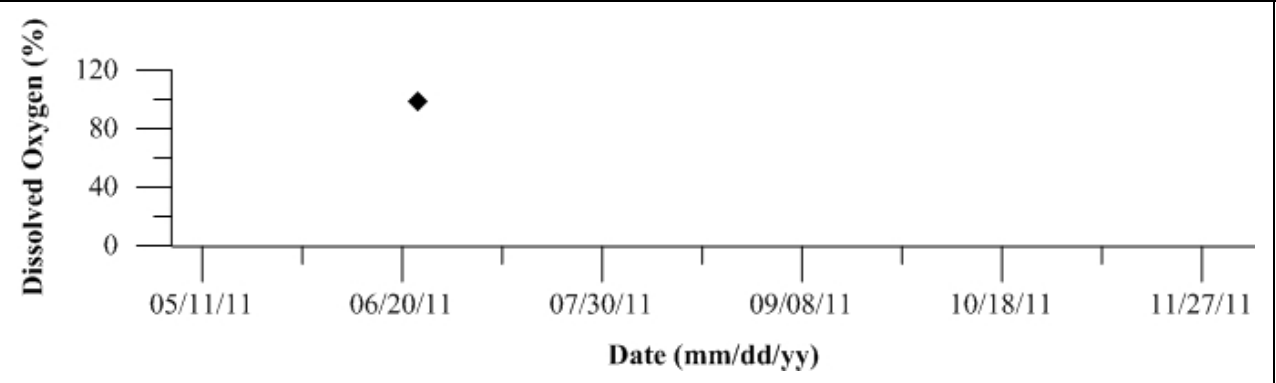
Figure 112: Grab sample Dissolved Oxygen (DO) percentage as measured with a YSI 6600V2 data sonde for Site 36 Del Puerto Creek. Data collected in 2011.

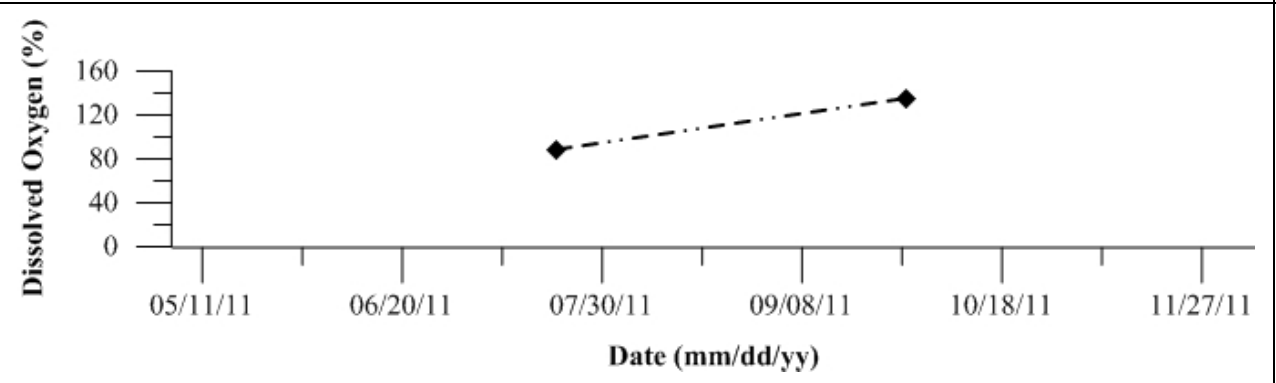
Figure 113: Grab sample Dissolved Oxygen (DO) percentage as measured with a YSI 6600V2 data sonde for Site 44 San Luis Drain End. Data collected in 2011.

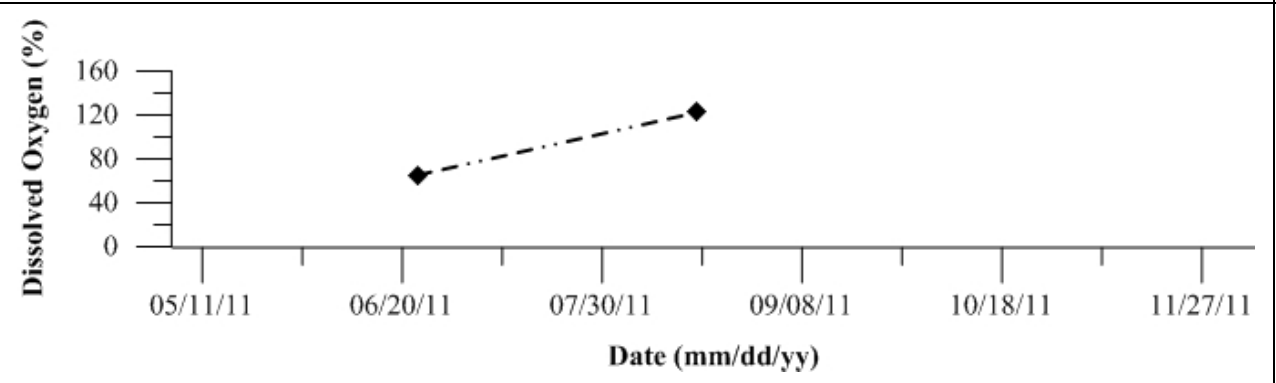
Figure 114: Grab sample Dissolved Oxygen (DO) percentage as measured with a YSI 6600V2 data sonde for Site 57 Ramona Lake. Data collected in 2011.

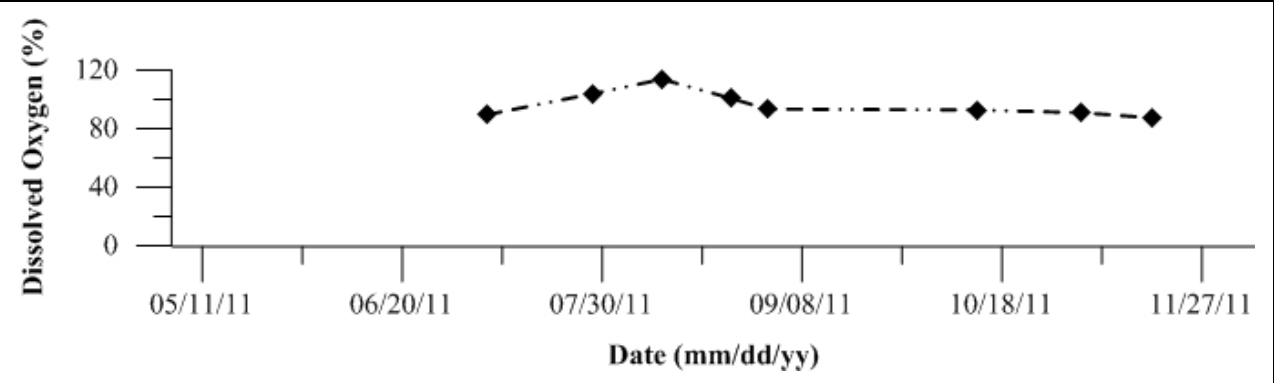
Figure 115: Grab sample Dissolved Oxygen (DO) percentage as measured with a YSI 6600V2 data sonde for Site 127 SJR at Brant Bridge. Data collected in 2011.

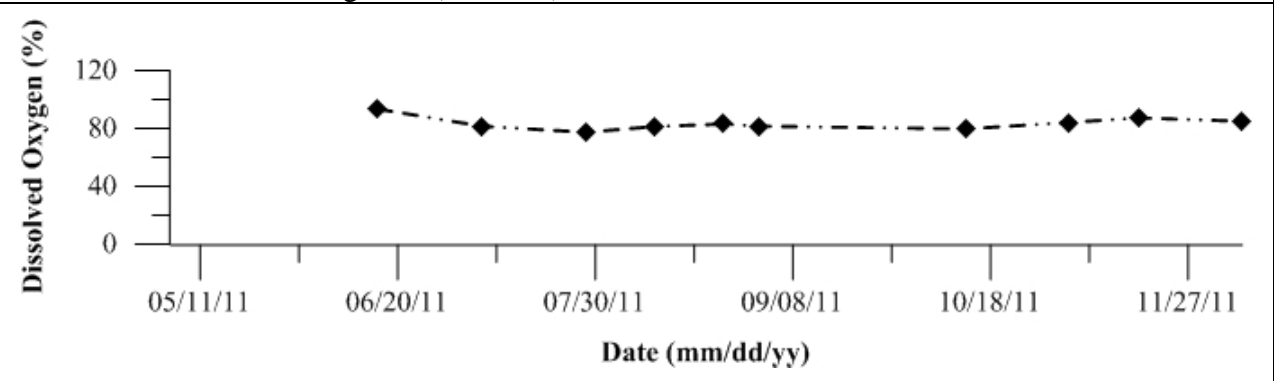
Figure 116: Grab sample Dissolved Oxygen (DO) percentage as measured with a YSI 6600V2 data sonde for Site 402 Light 18 (Node 96). Data collected in 2011.

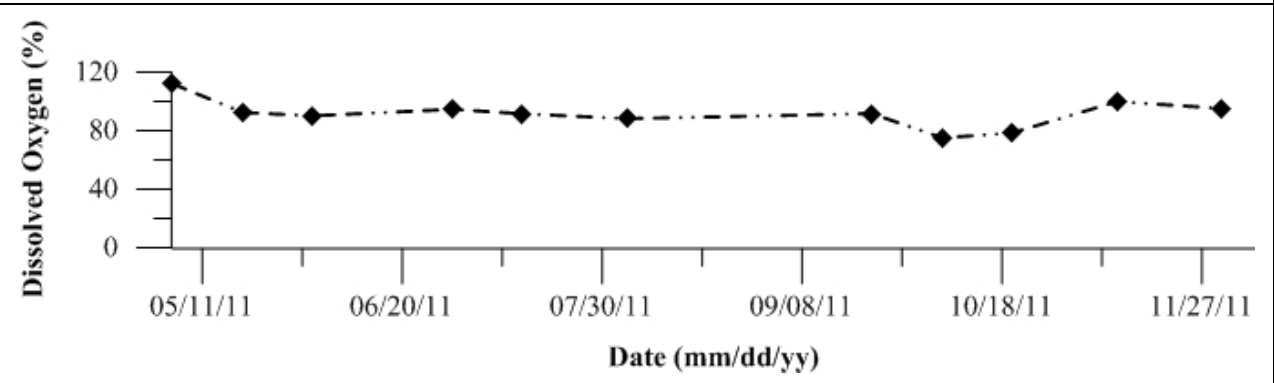
Figure 117: Grab sample Dissolved Oxygen (DO) percentage as measured with a YSI 6600V2 data sonde for Site 405 Calaveras River. Data collected in 2011.

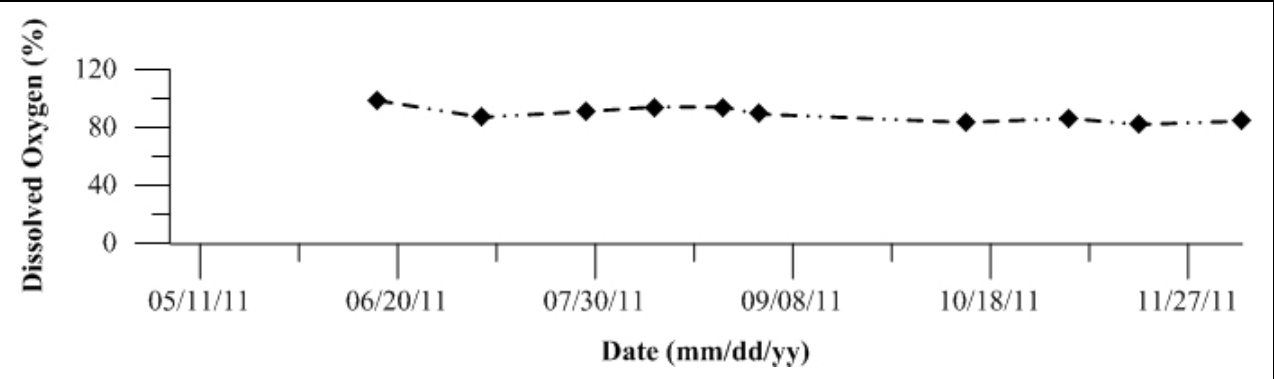
Figure 118: Grab sample Dissolved Oxygen (DO) percentage as measured with a YSI 6600V2 data sonde for Site 406 RM 35.8 Light 38 DWSC. Data collected in 2011.

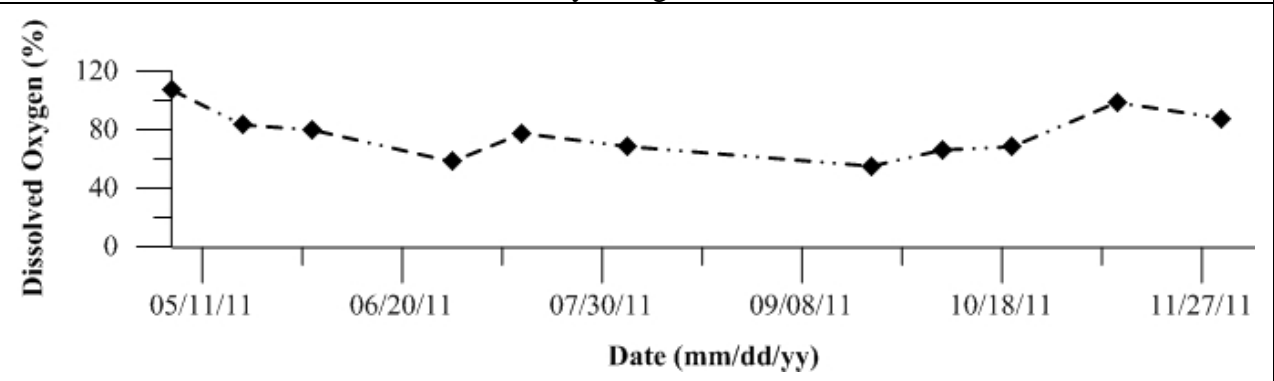
Figure 119: Grab sample Dissolved Oxygen (DO) percentage as measured with a YSI 6600V2 data sonde for Site 410 Bear Creek at Trinity Bridge. Data collected in 2011.

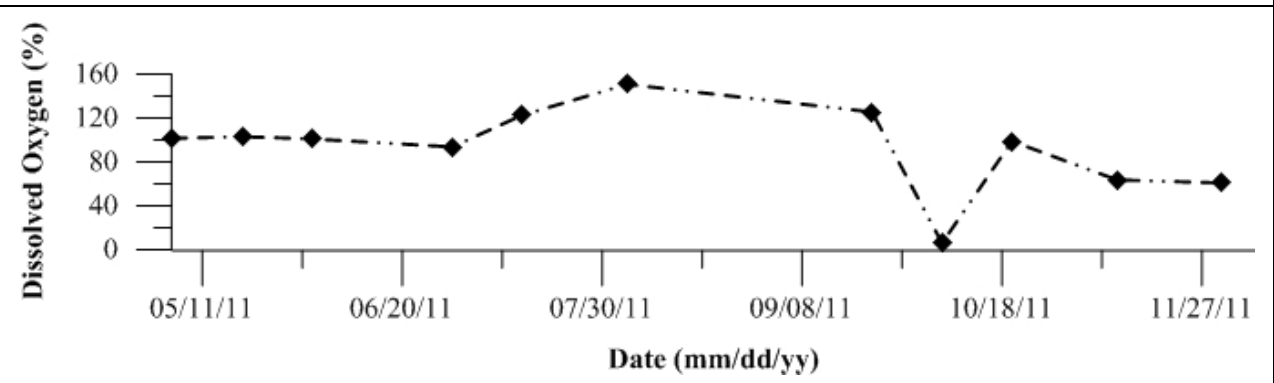
Figure 120: Grab sample Dissolved Oxygen (DO) percentage as measured with a YSI 6600V2 data sonde for Site 413 Smith Canal at Yosemite Lake. Data collected in 2011.

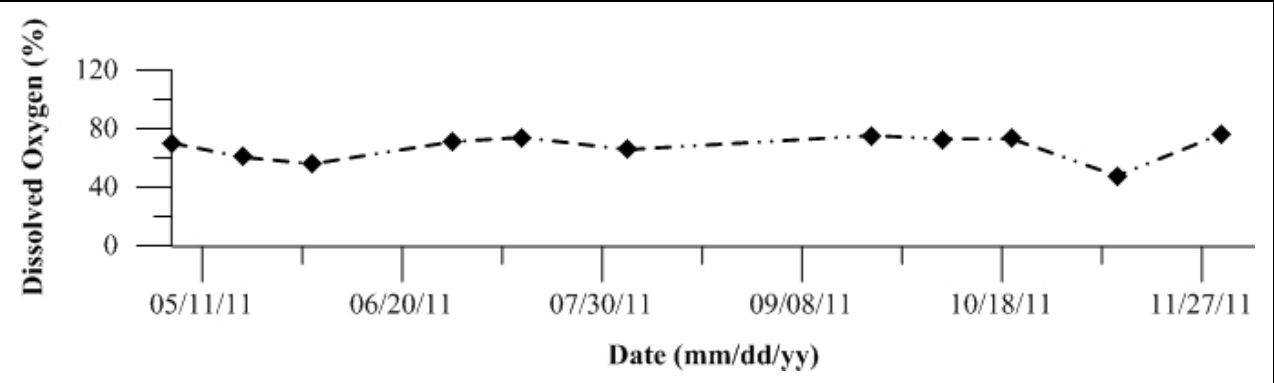
Figure 121: Grab sample Dissolved Oxygen (DO) percentage as measured with a YSI 6600V2 data sonde for Site 420 Mosher Slough at Mariners Dr. Data collected in 2011.

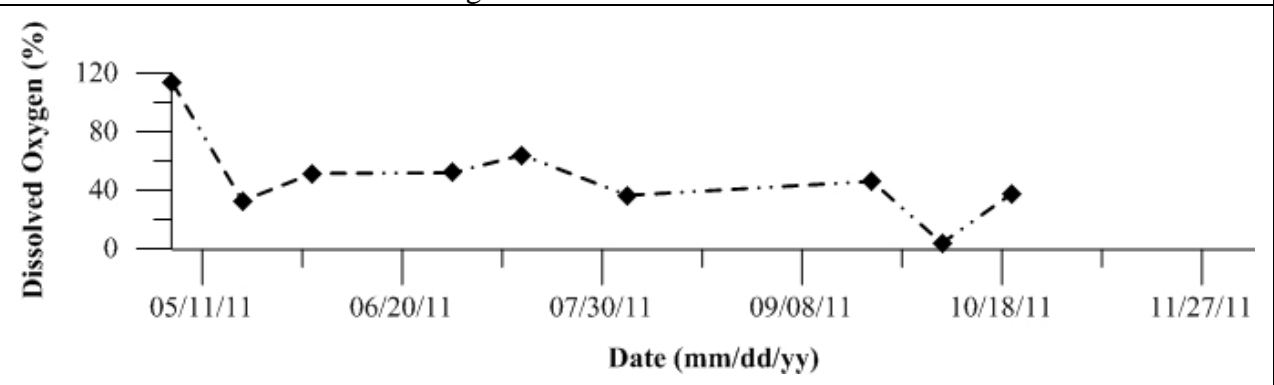
Figure 122: Grab sample Dissolved Oxygen (DO) percentage as measured with a YSI 6600V2 data sonde for Site 421 5 Mile Slough at Hazelwood Ave. Data collected in 2011.

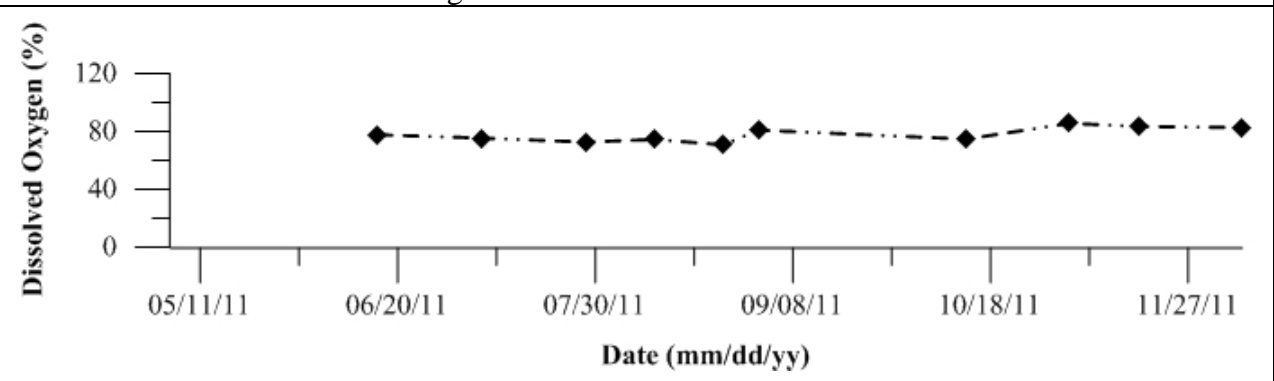
Figure 123: Grab sample Dissolved Oxygen (DO) percentage as measured with a YSI 6600V2 data sonde for Site 424 14mi Slough. Data collected in 2011.

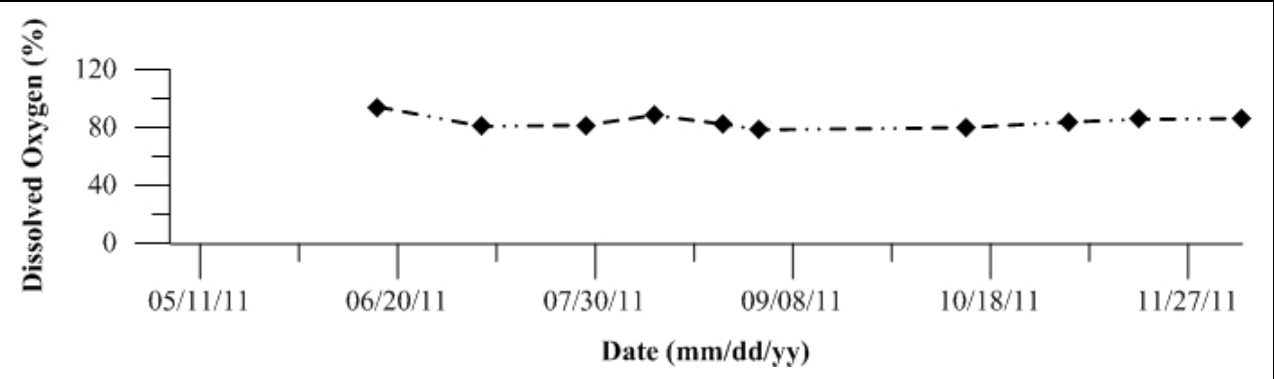
Figure 124: Grab sample Dissolved Oxygen (DO) percentage as measured with a YSI 6600V2 data sonde for Site 425 Turner Cut. Data collected in 2011.

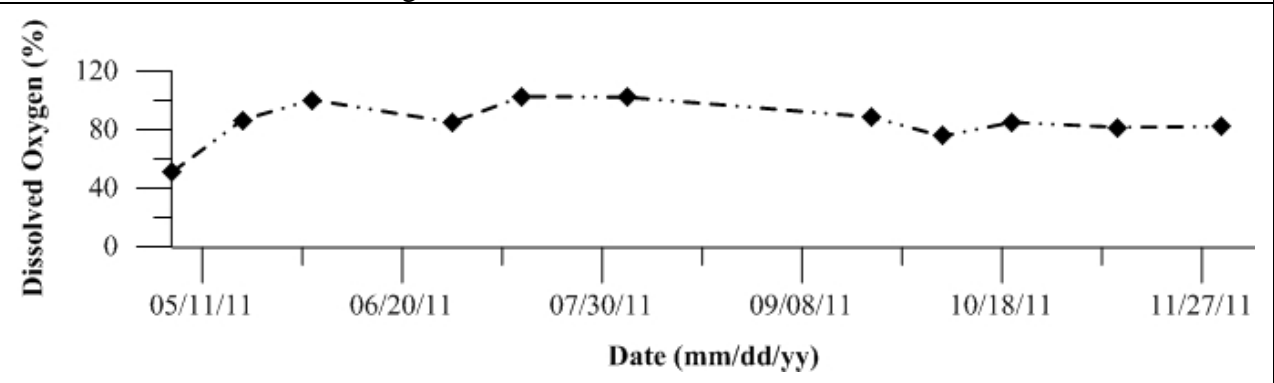
Figure 125: Grab sample Dissolved Oxygen (DO) percentage as measured with a YSI 6600V2 data sonde for Site 426 Turning Basin at Morelli Park Launch. Data collected in 2011.

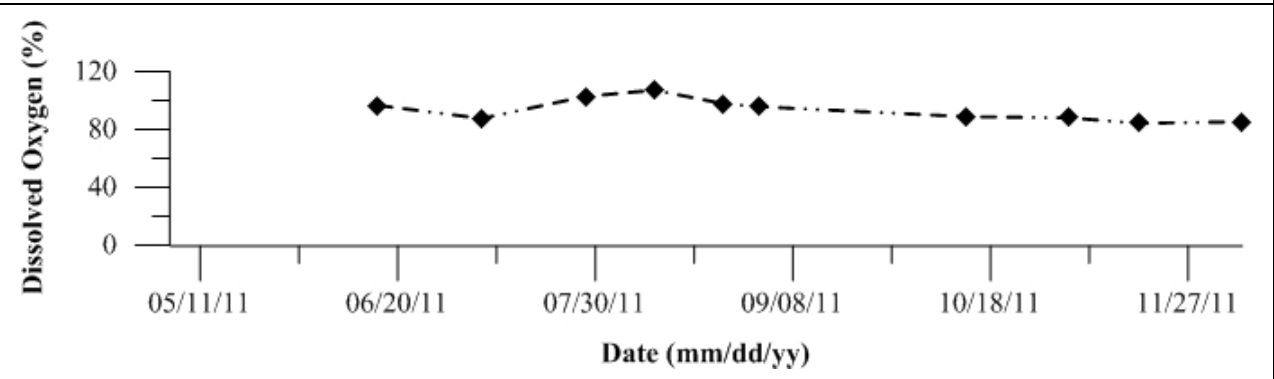
Figure 126: Grab sample Dissolved Oxygen (DO) percentage as measured with a YSI 6600V2 data sonde for Site 427 RM 39 Near Louis Park. Data collected in 2011.

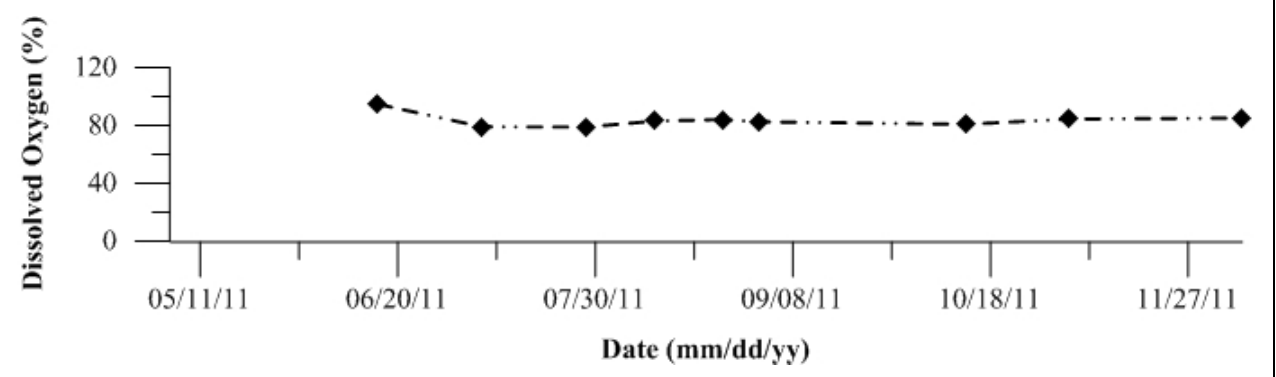
Figure 127: Grab sample Dissolved Oxygen (DO) percentage as measured with a YSI 6600V2 data sonde for Site 428 RM 33.2 Upstream of Acker Isl. Data collected in 2011.

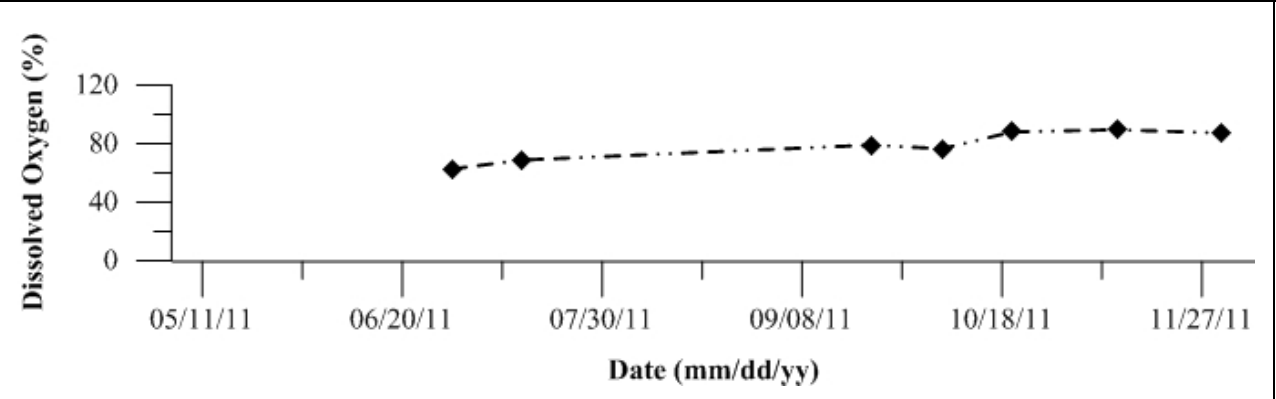
Figure 128: Grab sample Dissolved Oxygen (DO) percentage as measured with a YSI 6600V2 data sonde for Site 433 Paradise Marina (Node 70). Data collected in 2011.

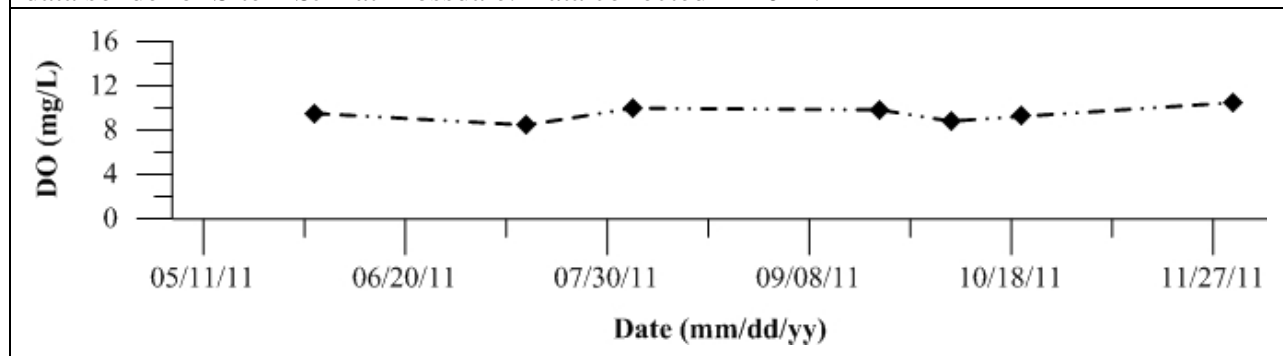
Figure 130: Grab sample Dissolved Oxygen (DO) concentration as measured with a YSI 6600V2 data sonde for Site 4 SJR at Mossdale. Data collected in 2011.

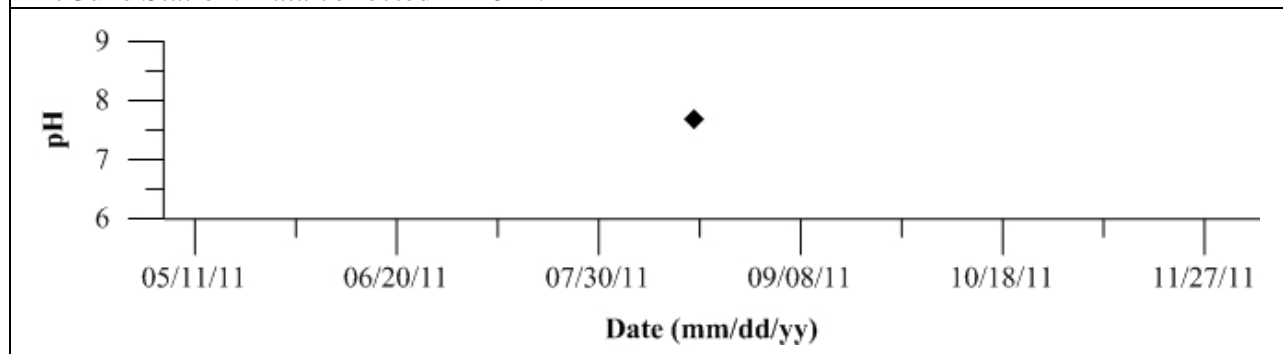
Figure 163: Grab sample pH as measured with a YSI 6600V2 data sonde for Site 5 SJR at McCune Station. Data collected in 2011.

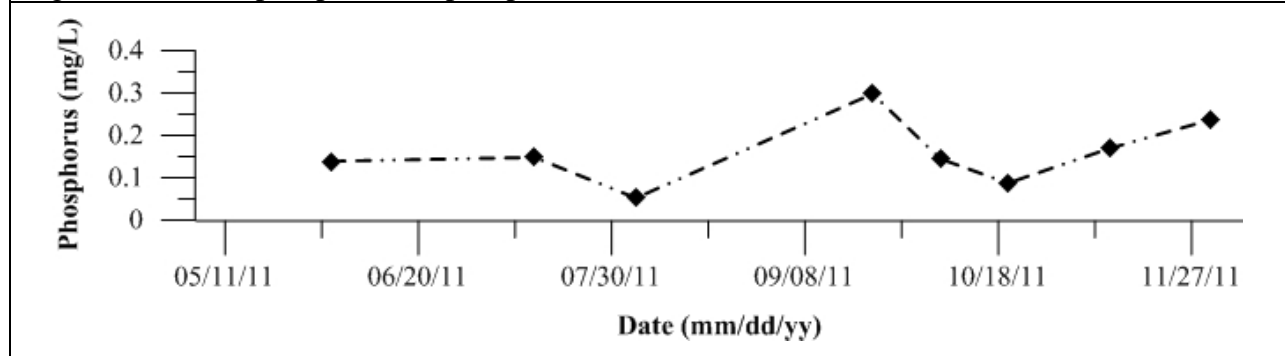
Figure 674: Total phosphorus as phosphate for Site 4 SJR at Mossdale. Data collected in 2011.

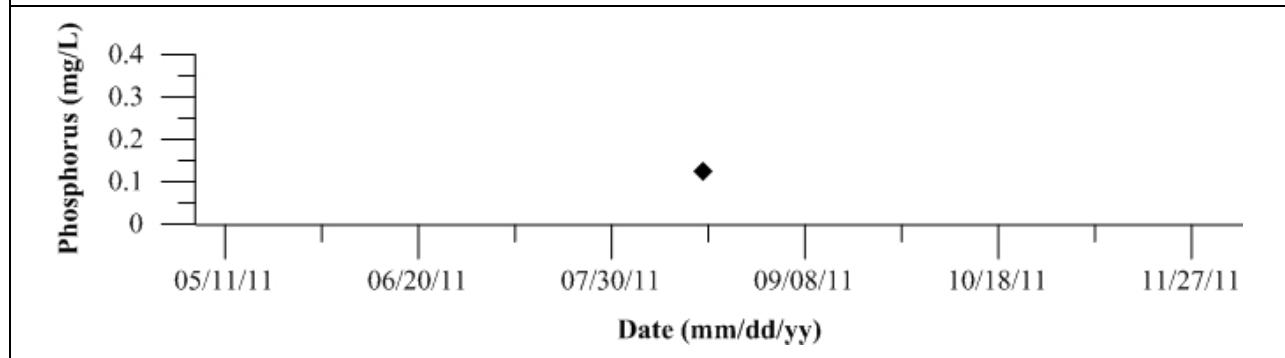
Figure 675: Total phosphorus as phosphate for Site 5 SJR at McCune Station. Data collected in 2011.
